The Uniform Building Inspection Report™

Single Family Residence:
4568 W Morrison Drive, Chicago, IL.

Inspection Date:
1/6/2016, 9:00:00 AM

Inspection Company:
Platinum Home Inspections, Inc.
William A. Riga Sr., IL LIC# 450-001923
Chicago, IL.
(773) 972-2243

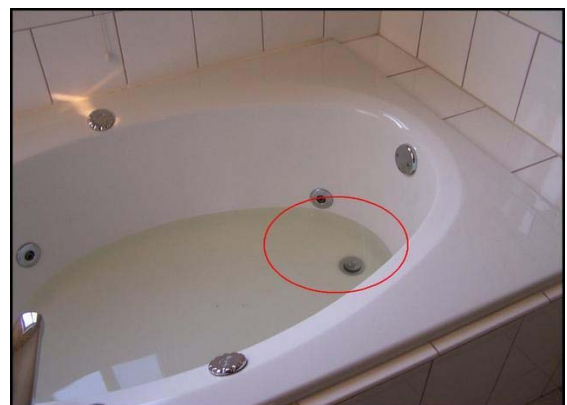
Photo: 4680 (1)

The drains are slow and will need to be routed or cleaned by a licensed plumber this condition exists on the second floor master bathroom. Repair, alteration, or replacement usually improves the efficiency of the component or system and is advised.

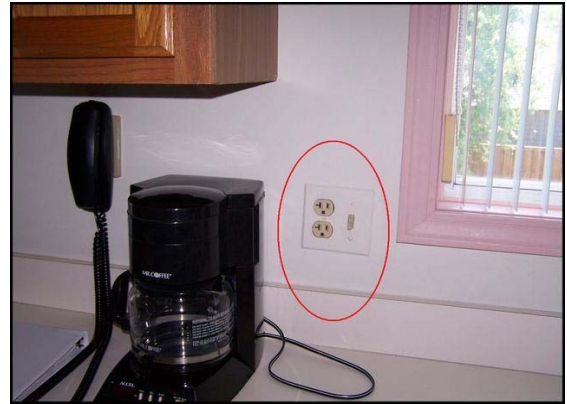
Photo: 8190.01 (1)

[U] [R] 8190.01: Receptacle outlet(s) intended for kitchen countertop use not GFCI type.

Kitchen Wall Receptacles The outlets at kitchen countertop are within 72 inches of a water source. Although Ground Fault Circuit Interrupters was not required when the house was built it is recommended that any outlet with 72 inches of a water source be replaced with a Ground Fault Circuit Interrupter for safety reasons. The replacement of these outlets would be considered an upgrade and is advised.

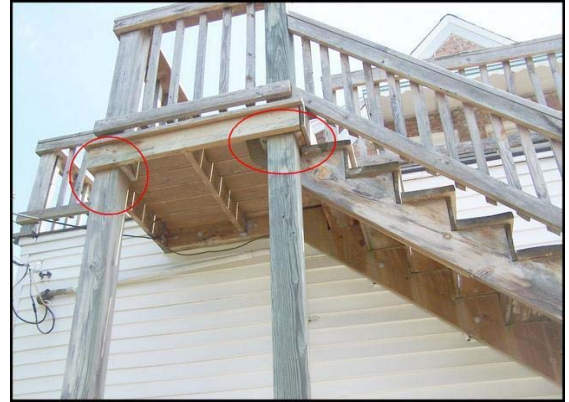
Photo: 9220.01 (1)

[H] [R] 9220.01: **Unsafe framing member potential.**
The main supporting 6x6 are nailed to the supporting fascia boards. It is recommend that all supporting members be through bolted with either hot dipped galvanized or stainless steel bolts.

It is recommended that a qualified licensed contractor review the finding and correct as needed.
