# The Uniform Building Inspection Report™

**Single Family Residence:**  
4568 W Morrison Drive, Chicago, IL.

**Inspection Date:**  
1/6/2016, 9:00:00 AM

**Inspection Company:**  
Platinum Home Inspections, Inc.  
William A. Riga Sr., IL LIC# 450-001923  
Chicago, IL.  
(773) 972-2243

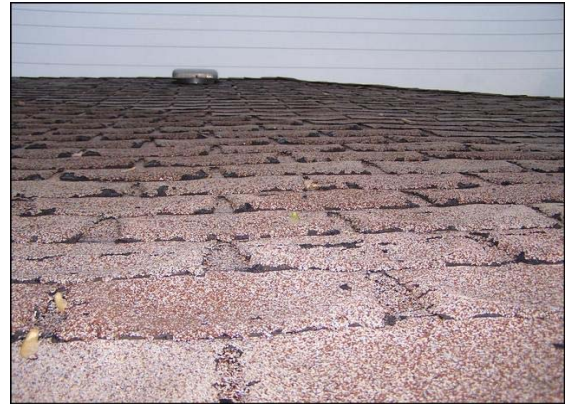
Photo: 1020.01 (1)

[P] [R] [R] 1020.01: The roof appears to be at the end of its useful life. Prepare to replace at this time. A second opinion is recommended.

The house roof is cracked and dried and aged prematurely. Should replace the roof at this time, by a licensed roofing contractor.

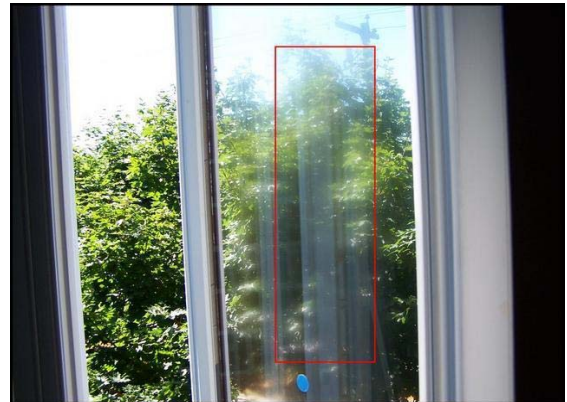
Photo: 1510.01 (1)

The window has lost its seal and needs to be replaced. See the windows which has been marked by an X with a grease pencil. Correction or modification of this finding decreases the probability of excessive deterioration of the noted component(s) and is recommended.

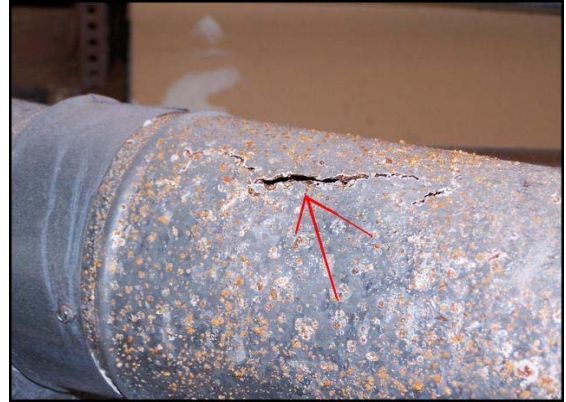
Photo: 2150.04 (1)

[H] [R] 2150.04: Heat system vent improper. THIS is a high efficiency Condensate Furnace and as such the vent pipe should be P.V.C. pipe. installation of a metal vent will cause corrosion due to the corrosive exhaust gasses. Recommend that the pipe be replaced with P.V.C. pipe and be exhausted through the side of the house as the manufacture intended. It is recommended that a qualified licensed contractor review the finding and correct as needed.

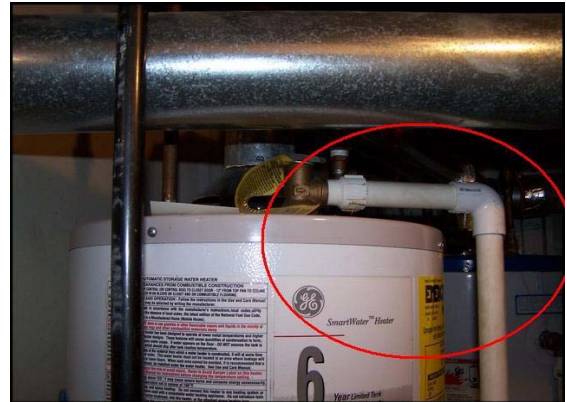
Photo: 4150.03 (1)

[H] [H] 4150.03: Water heater pressure / temperature relief valve discharge line improper type.

The Temperature Pressure Relief discharge line is currently a flex material. The discharge line should be a non threaded end rigid three quarter pipe only which extends six to twelve inches above finish floor level. Correction is advised.. It is recommended that a qualified licensed contractor review the finding and correct as needed.

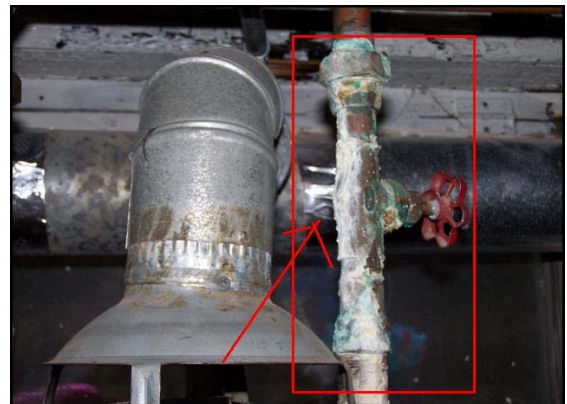
Photo: 4430 (1)

[E] [P] 4430: Water pipes or fittings corroded and/or leaking.

The union on top of the water heater is corroded and leaking. Recommend replacement of the defective union and any further correction needed.

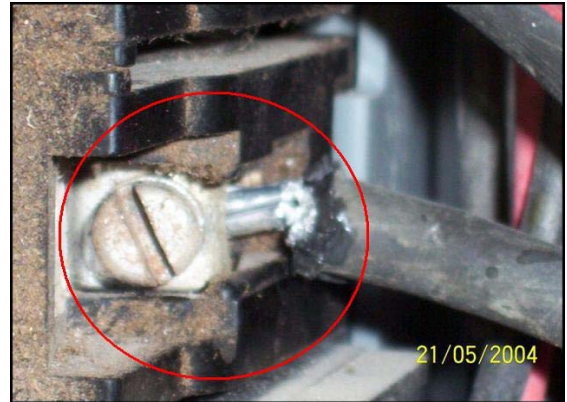
Photo: 5100.04 (1)

[E] [H] [R] 5100.04: Main panel faulty or otherwise amiss. The main entrance connector has been compromised. Conductors have been cut. Left in the present condition the component may continue to deteriorate or cause undue damage to other components. Corrections by a qualified licensed contractor are advised. See series 5100.04 photo(s)

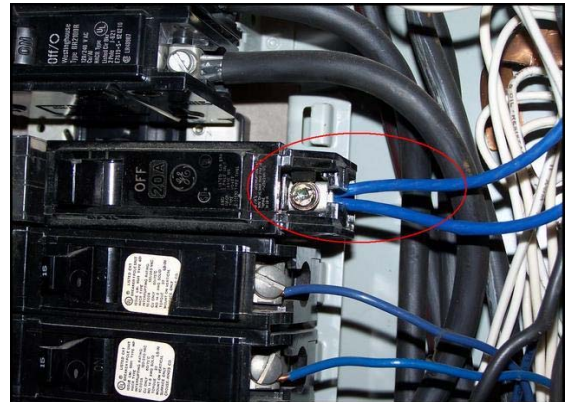
Photo: 5230 (1)

[R] [H] 5230:  
Double wires on breaker or fuse.  
Two circuit breakers are "double tapped", where 2 or more wires are clamped in a circuit breaker terminal that's designed for only 1 wire. This is a safety hazard since wires may loosen and cause arcing, sparking and fires. Recommend having a qualified, licensed electrician evaluate and repair. One possible solution is to install additional circuit breakers. It is recommended that a qualified licensed contractor review the finding and correct as needed. See series 5230 photo(s)

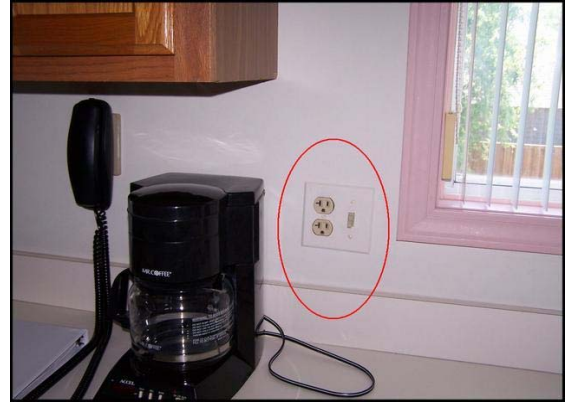
Photo: 8190.01 (1)

[U] [R] 8190.01: Receptacle outlet(s) intended for kitchen countertop use not GFCI type.

**Kitchen Wall Receptacles** The outlets at kitchen countertop are within 72 inches of a water source. Although Ground Fault Circuit Interrupters was not required when the house was built it is recommended that any outlet with 72 inches of a water source be replaced with a Ground Fault Circuit Interrupter for safety reasons. The replacement of these outlets would be considered an upgrade and is advised.

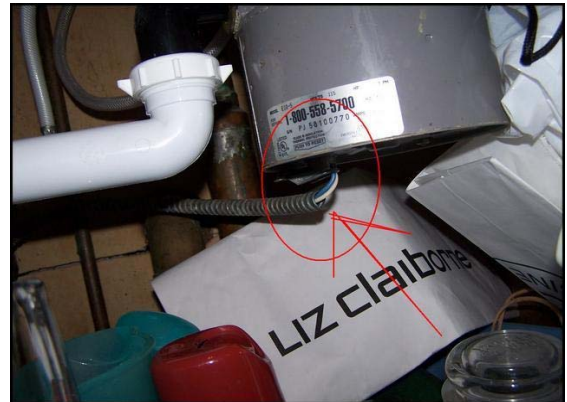
Photo: 8450.01 (1)

The electrical supply to the disposal should not ave a exposed junction, or be able to be damaged by contact. Recommend that the electrical supply wire be attached with a permanent electrical connector. It is recommended that a qualified licensed contractor review the finding and correct as needed.

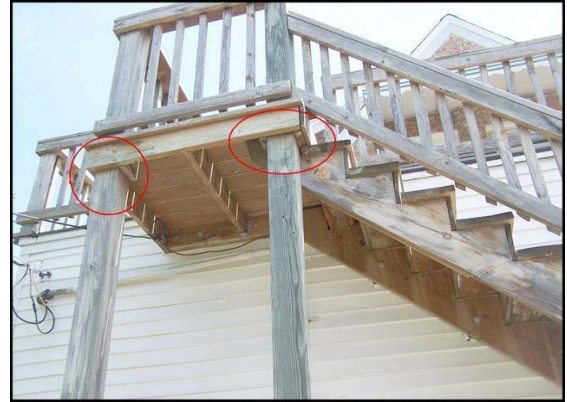
Photo: 9220.01 (1)

**[H] [R] 9220.01: Unsafe framing member potential.**  
The main supporting 6x6 are nailed to the supporting fascia boards. It is recommend that all supporting members be through bolted with either hot dipped galvanized or stainless steel bolts.

It is recommended that a qualified licensed contractor review the finding and correct as needed.  
See series 9220.01 photo(s)
