The Uniform Building Inspection Report™ Condensed

Single Family Residence:
4568 W Morrison Drive, Chicago, IL.

Inspection Date:
1/6/2006, 9:00:00 AM

Inspection Company:
Platinum Home Inspections, Inc.
William A. Riga Sr., 050-0001923
,
Chicago , IL. 60632
(773) 972-2243

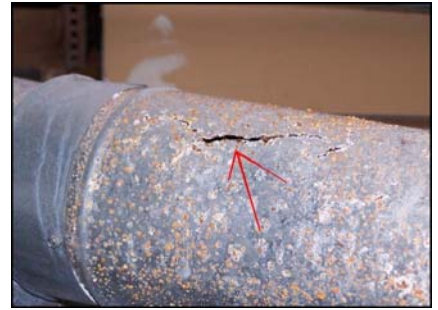
Photo: 2150.04 (1)

[H] [R] 2150.04: Heat system vent improper.
THIS is a high efficiency Condensate Furnace and as such the vent pipe should be P.V.C. pipe. installation of a metal vent will cause corrosion due to the corrosive exhaust gasses. Recommend that the pipe be replaced with P.V.C. pipe and be exhausted through the side of the house as the manufacture intended. It is recommended that a qualified licensed contractor review the finding and correct as needed.
See series 2150.04 photo(s)

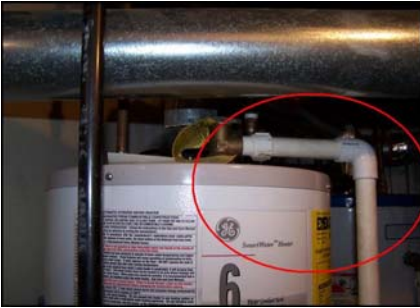
Photo: 4150.03 (1)

[H] [H] 4150.03: Water heater pressure / temperature relief valve discharge line improper type.

The Temperature Pressure Relief discharge line is currently a flex material. The discharge line should be a non threaded end rigid three quarter pipe only which extends six to twelve inches above finish floor level. Correction is advised.. It is recommended that a qualified licensed contractor review the finding and correct as needed.

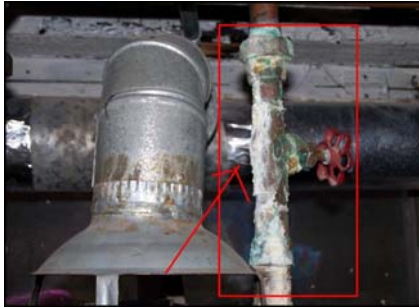
Photo: 4430 (1)

[E] [P] 4430: Water pipes or fittings corroded and/or leaking. The union on top of the water heater is corroded and leaking. Recommend replacement of the defective union and any further correction needed.

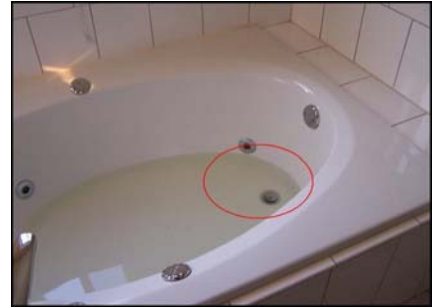
Photo: 4680 (1)

[E] 4680: Fixture drain slow or clogged. The drains are slow and will need to be routed or cleaned by a licensed plumber this condition exists on the second floor master bathroom. Repair, alteration, or replacement usually improves the efficiency of the component or system and is advised. See series 4680 photo(s)

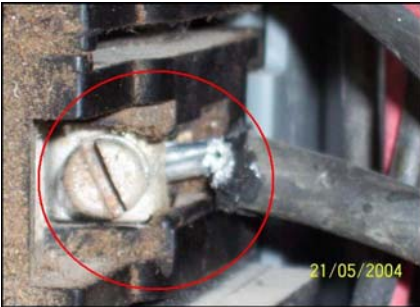
Photo: 5100.04 (1)

[E] [H] [R] 5100.04: Main panel faulty or otherwise amiss. The main entrance connector has been compromised. Conductors have been cut. Left in the present condition the component may continue to deteriorate or cause undue damage to other components. Corrections by a qualified licensed contractor are advised. See series 5100.04 photo(s)

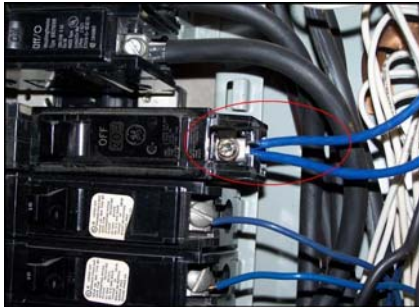
Photo: 5230 (1)

[R] [H] 5230:
Double wires on breaker or fuse.
Two circuit breakers are "double tapped", where 2 or more wires are clamped in a circuit breaker terminal that's designed for only 1 wire. This is a safety hazard since wires may loosen and cause arcing, sparking and fires. Recommend having a qualified, licensed electrician evaluate and repair. One possible solution is to install additional circuit breakers. It is recommended that a qualified licensed contractor review the finding and correct as needed. See series 5230 photo(s)

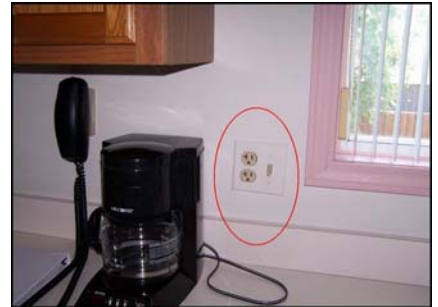
Photo: 8190.01 (1)

[U] [R] 8190.01: Receptacle outlet(s) intended for kitchen countertop use not GFCI type.
Kitchen Wall Receptacles The outlets at kitchen counter top are within 72 inches of a water source. Although Ground Fault Circuit Interrupters was not required when the house was built it is recommended that any outlet with 72 inches of a water source be replaced with a Ground Fault Circuit Interrupter for safety reasons. The replacement of these outlets would be considered an upgrade and is advised.
See series 8190.01 photo(s)

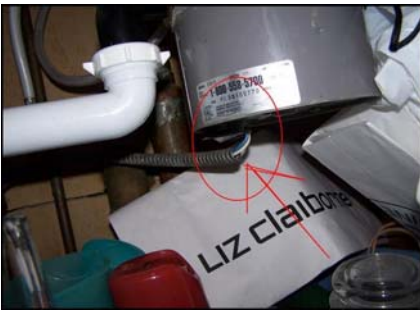
Photo: 8450.01 (1)

[H] [R] 8450.01: Disposal electric supply wire not secure to unit. The electrical supply to the disposal should not ave a exposed junction, or be able to be damaged by contact. Recommend that the electrical supply wire be attached with a permanent electrical connector. It is recommended that a qualified licensed contractor review the finding and correct as needed.
See series 8450.01 photo(s)

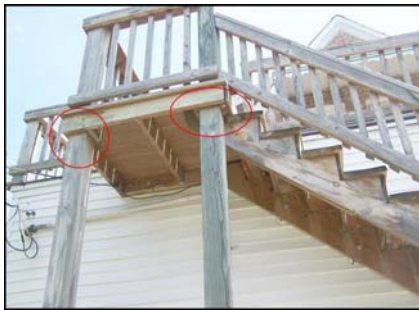
Photo: 9220.01 (1)

[H] [R] 9220.01: Unsafe framing member potential. The main supporting 6x6 are nailed to the supporting facia boards. It is recommend that all supporting members be through bolted with either hot dipped galvanized or stainless steel bolts.
It is recommended that a qualified licensed contractor review the finding and correct as needed.
See series 9220.01 photo(s)
