The Uniform Building Inspection Report™

Single Family Residence:
4568 W Morrison Drive, Chicago, IL.

Inspection Date:
1/6/2006, 9:00:00 AM

Inspection Company:
Platinum Home Inspections, Inc.
William A. Riga Sr., IL LIC# 450-001923
Chicago, IL.
(773) 972-2243

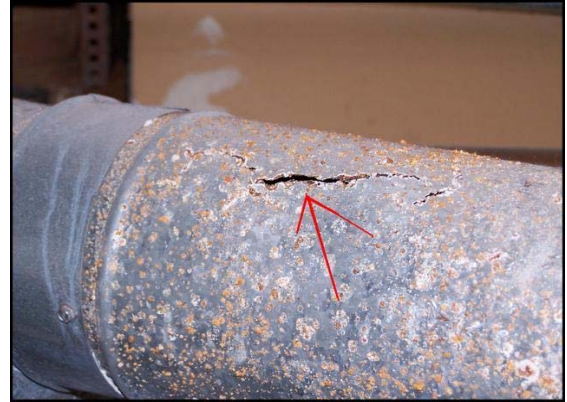
Photo: 2150.04 (1)

[H] [R] 2150.04: Heat system vent improper. THIS is a high efficiency Condensate Furnace and as such the vent pipe should be P.V.C. pipe. installation of a metal vent will cause corrosion due to the corrosive exhaust gasses. Recommend that the pipe be replaced with P.V.C. pipe and be exhausted through the side of the house as the manufacture intended. It is recommended that a qualified licensed contractor review the finding and correct as needed.
